Building Performance Evaluation: In-use Post Occupancy Evaluation – a Welsh Case Study

Aberfawr Terrace, Abertridwr, Wales

3rd February 2016

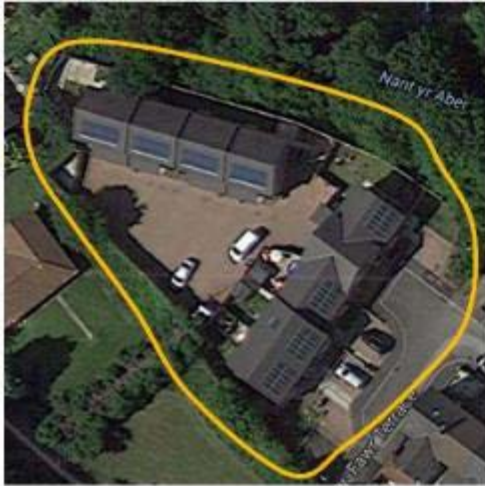
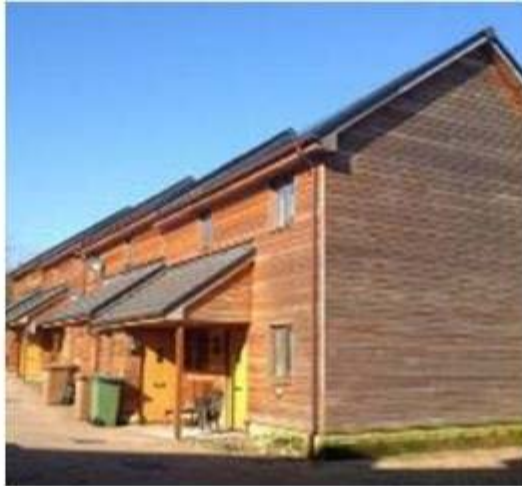
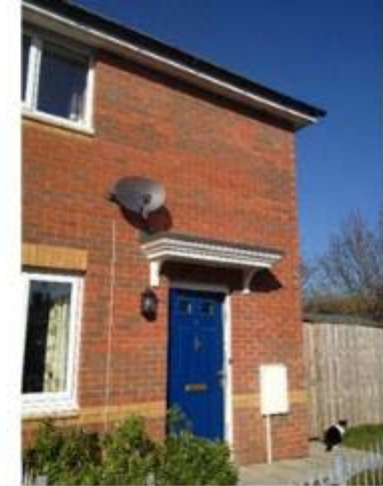
- All houses CfSH level 3+ and flats CfSH level: 4, latterly DECC grant during construction in 2010.
- Flat construction - 0.28, 0.1 and 0.1 W/m²K U values for exterior walls, roof and ground floor, timber frame, sheeps wool insulation, cedar clad, triple glazing, 1 kW PV;
- House Construction: 0.18, 0.1 and 0.2 W/m²K U values for exterior walls, roof and ground floor; brick/block cavity construction, double glazing, no PV.
- Heating/Ventilation: electric only: NIBE EASHPs + underfloor heating

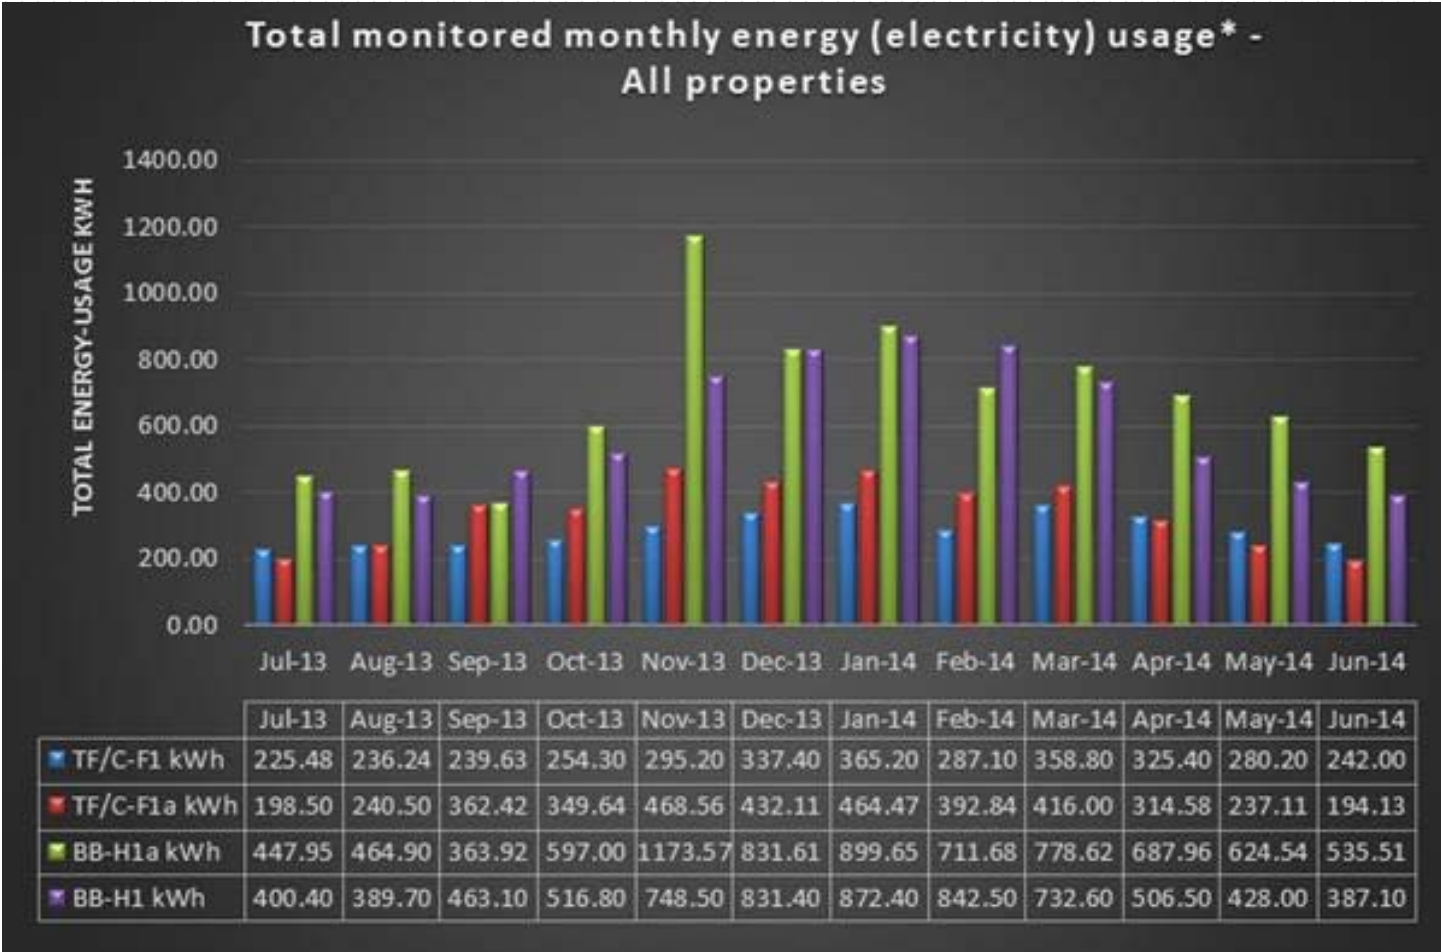
Some key Findings Monitoring – Energy Usages all dwellings

Occupancy patterns are linked to higher energy usage as are greater exposed facades

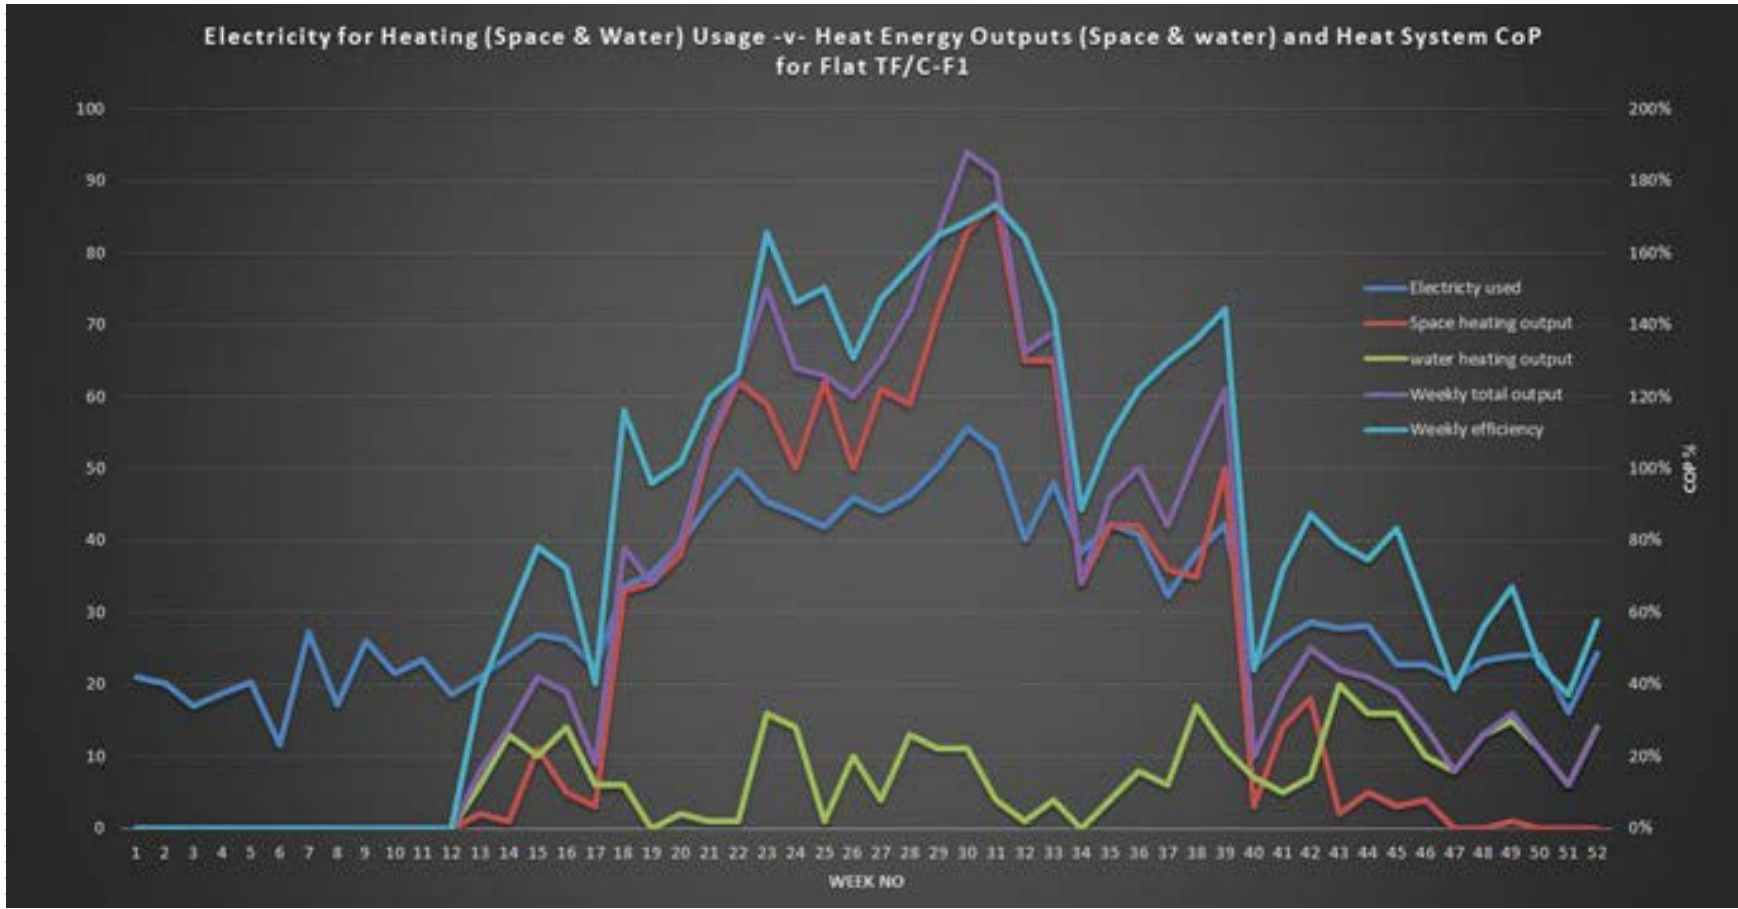
Some key Findings Monitoring – EASHP COP: Flat

week 1-12 represent non-heating demand July–September, overall trend: Total Electricity usage, (dark blue), Total Heat output, (purple) typical of increasing/decreasing heat outputs for the SAP heat demand 10-05

NIBE SYSTEM	NIBE-Published CoP	Derived CoP Maximum (Difference)	Derived CoP Minimum (Difference)
Fighter 205/Flat TF/C-F1	3.15	1.733 (-1.417)	0.370 (-2.78)
